Manhole Inspection Summary

Manhole # S15GG_015MH

Insp Date: **9/19/07 4:18 PM**

Location Address: **UNDER RR TRACKS**

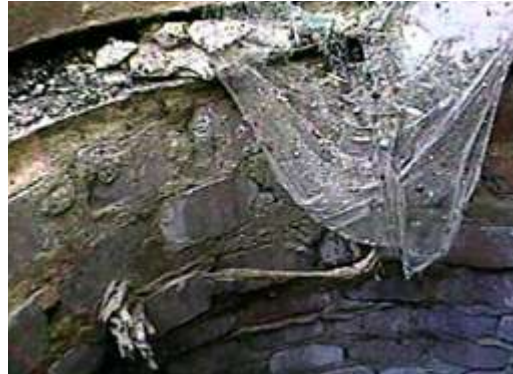
Defect 1

Condition: ☐ Sound ☒ **Cracked** ☐ Root Intrusion ☒ **Loose Brick** ☐ Deteriorated

Steps Count: **3** Missing: **1** ☒ **Corroded**

CORRODED RUNG + LOOSE BRICK
ADJ

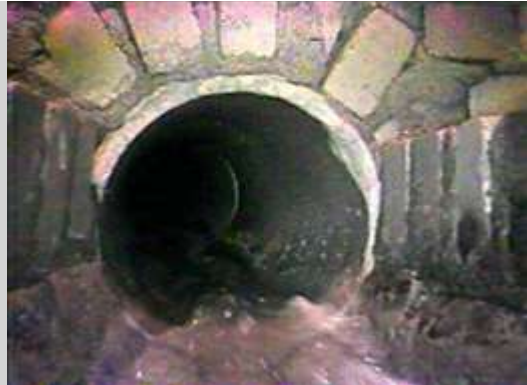
12 O'Clock Outflow

10 in. Circular Gravity Sewer
Pipe Out @ 12 O'Clock

Pipe Height: (in.) Direct
Pipe Material: **Clay** ☐ Pipe Lined
Invert Depth: **6.48** (ft.) Flow Characteristics: **Fast**
Deposits: ☒ None ☐ Mud ☐ Sludge ☐ Debris ☐ Grease
Silt Depth: (in.) Deposits Extent:
Infiltration: **None** Pipe Seal Cond: **Sound**

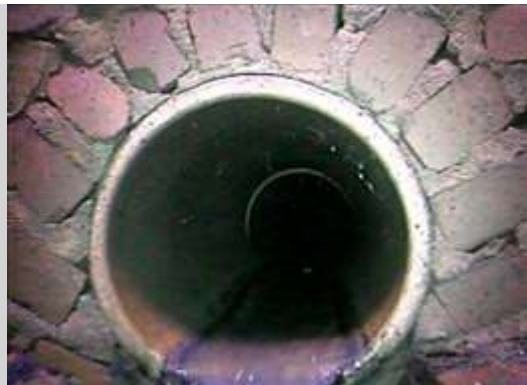
6 O'Clock Inflow

10 in. Circular Gravity Sewer
Pipe In @ 6 O'Clock

Pipe Height: (in.) Direct
Pipe Material: **Clay** ☐ Pipe Lined
Invert Depth: **5.87** (ft.) Flow Characteristics: **Fast**
Deposits: ☒ None ☐ Mud ☐ Sludge ☐ Debris ☐ Grease
Silt Depth: (in.) Deposits Extent:
Infiltration: **None** Pipe Seal Cond: **Sound**
